Front A/C Compressor Seal Leaking

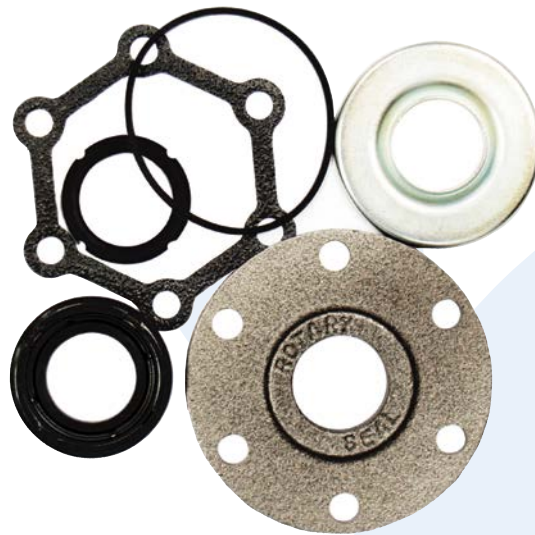
A08-8027
York type Ceramic Seal Kit

Early Compressor seals were a two-part seal where a ceramic disc with an internal O ring that sealed the disc to the shaft, ran against a finely machined metal disc situated in the front housing of the compressor. Oil in-between these surfaces both lubricates and provides part of the sealing ability of the seal. This type of seal will leak refrigerant if allowed to dry out which is why it is recommended to always use an Air-Conditioner at least monthly to allow oil movement which assists sealing. It was not unheard of for this type of compressor seal to leak initially before the compressor is first operated with refrigerant in the system and then seal after running.

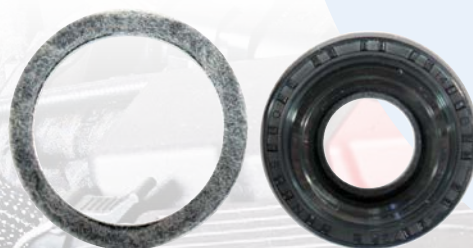
A08-8131
Seal Kit Sanden SD7H13, SD7H15
Including 8908, 8909

Later Model Compressors for example Sanden, now have O Ring seals which run on the front shaft. These seals also will allow a small amount of oil past them as per the ceramic type seals as part of the lubrication and sealing process so it is quite normal to see some oil behind the front hub. What does damage compressors is when they are operated in very dusty conditions without a dust cover and dust combining with this oil creates a grinding paste that causes wear on the front shaft where the seal runs. Replacing a seal in this situation will not stop refrigerant leakage due to insufficient pressure of the O ring onto the worn shaft.
