Alternator Clutch Pulley

The importance of Alternator clutch pulleys becomes apparent when we look at some other consequences of their failure.

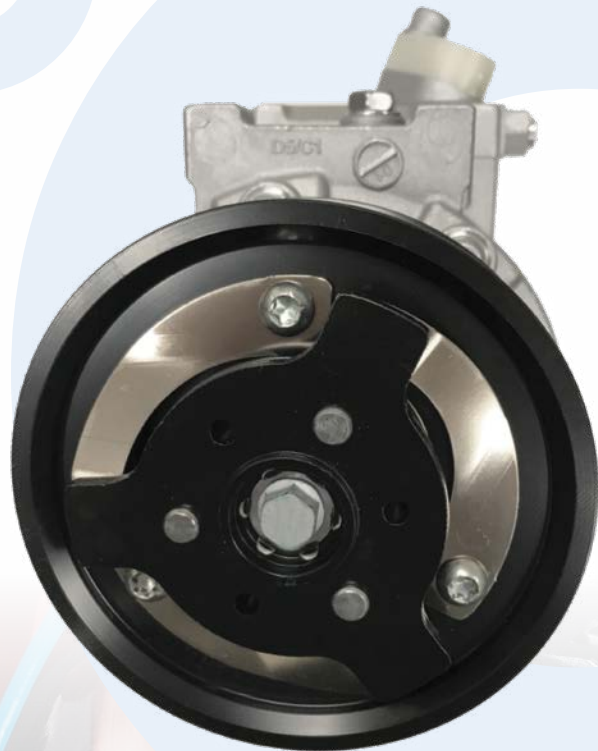
Genuine Valeo **A09-9411GQ**
Direct Drive Compressor with external
Displacement control to Suit VW Diesel
TDI 2.0 Litre Golf
